# Sources of Contamination within the Upper Tributaries of the Portage Watershed to Reduce Harmful Algal Blooms in Lake Erie

Authors: *N. Mirochnitchenko, K. Ruckert, S. Hutchins*

Bowling Green State University **Ohio** Lake Erie Protection Fund

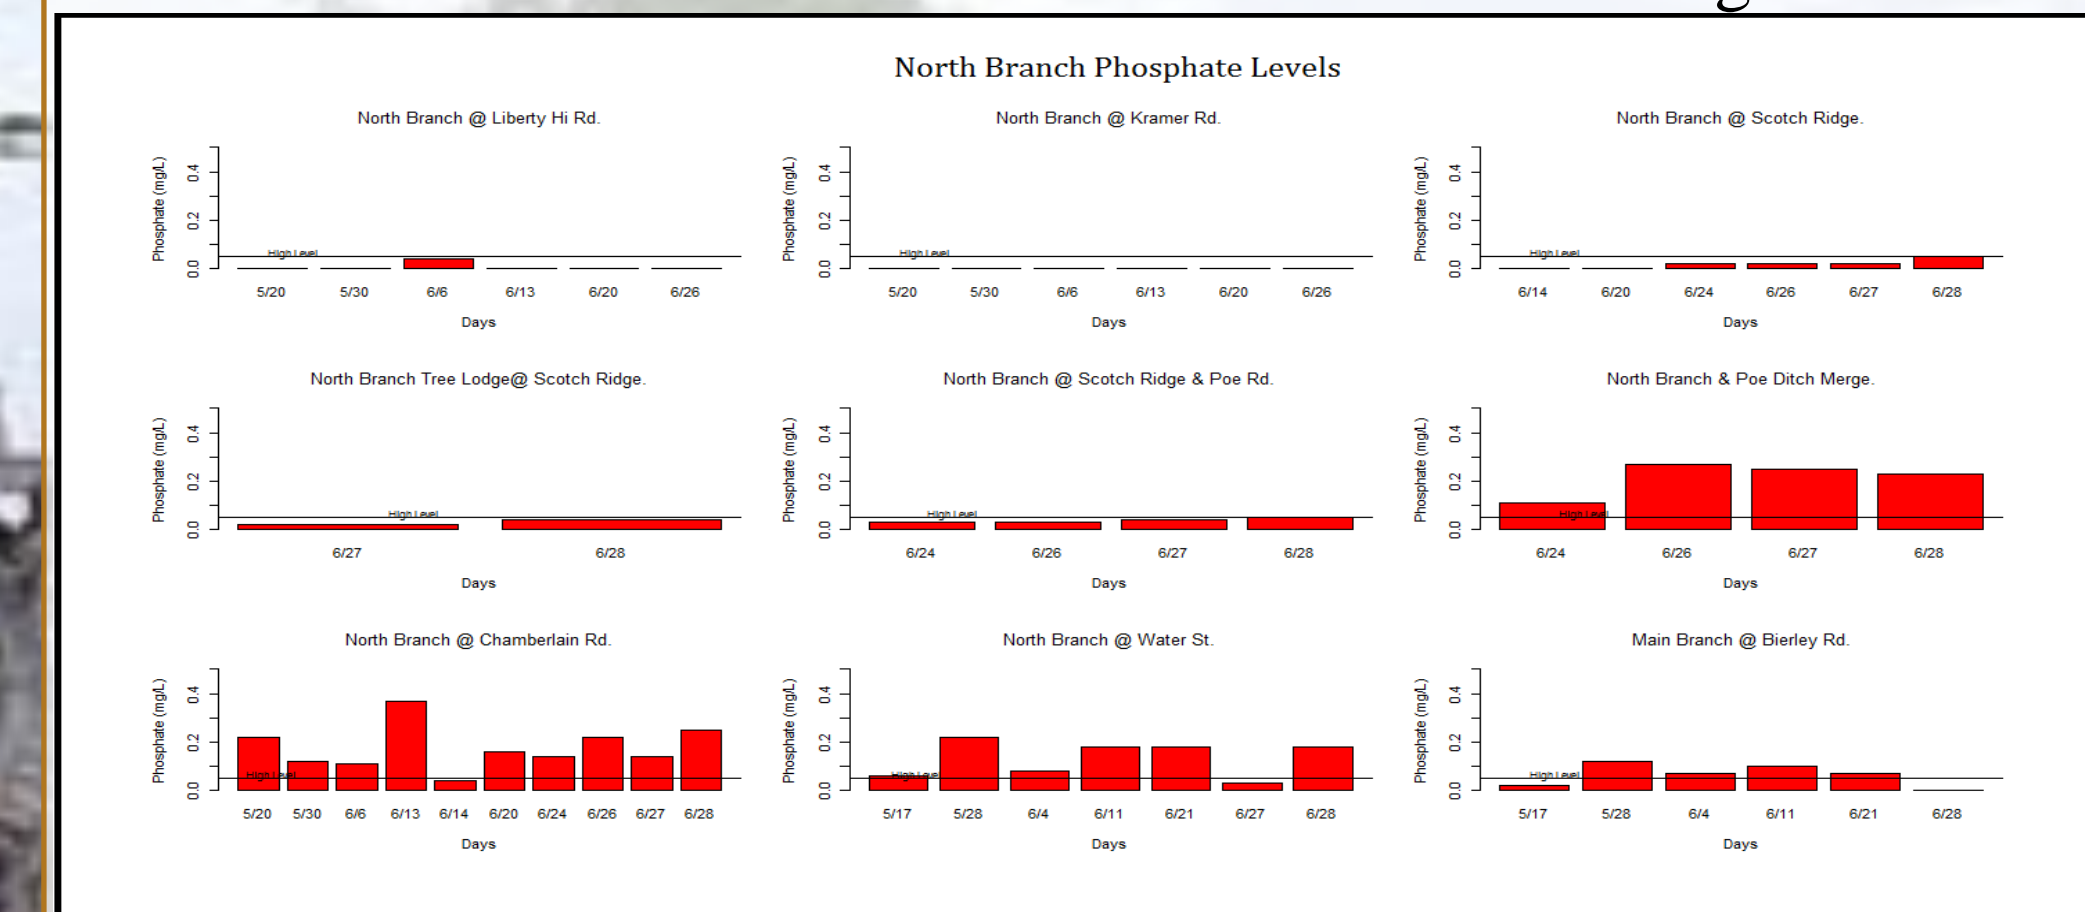
Figure 4: This figure shows the dissolved phosphate levels for the North Branch tributary of the Portage River.

The North Branch and South/East Branch consistently had the higher rates of contamination (Figure 3). Figure 4 shows that the high contamination levels of phosphate on the North Branch were from Poe Ditch and continue downstream from the merge.

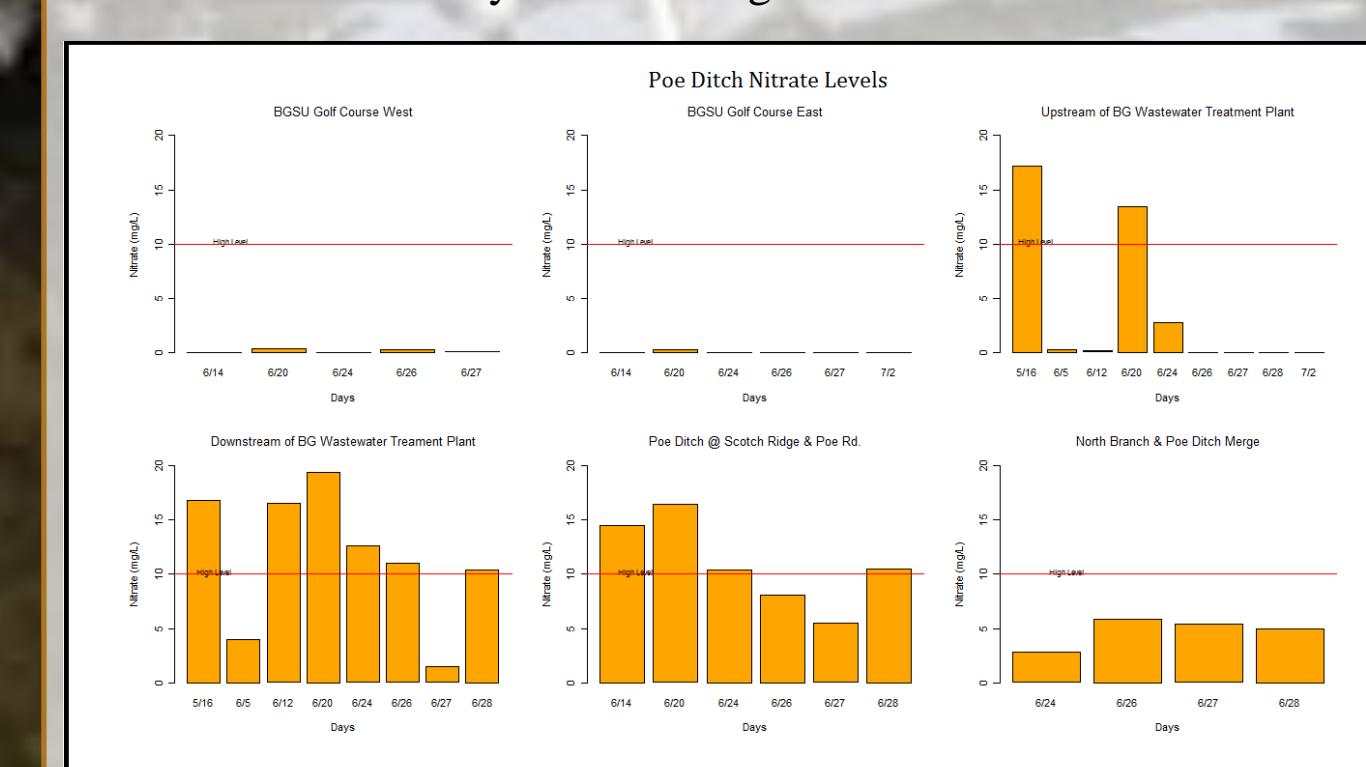
Figure 5: This figure shows the nitrate + nitrite levels for Poe Ditch.

Both nitrate and phosphate levels spike downstream from the outflow of the BG Wastewater Treatment plant (BG WWTP) (Figure 5 & 6). BG WWTP plans to add phosphate reducing biological practices by 2015 (BG WWTP).

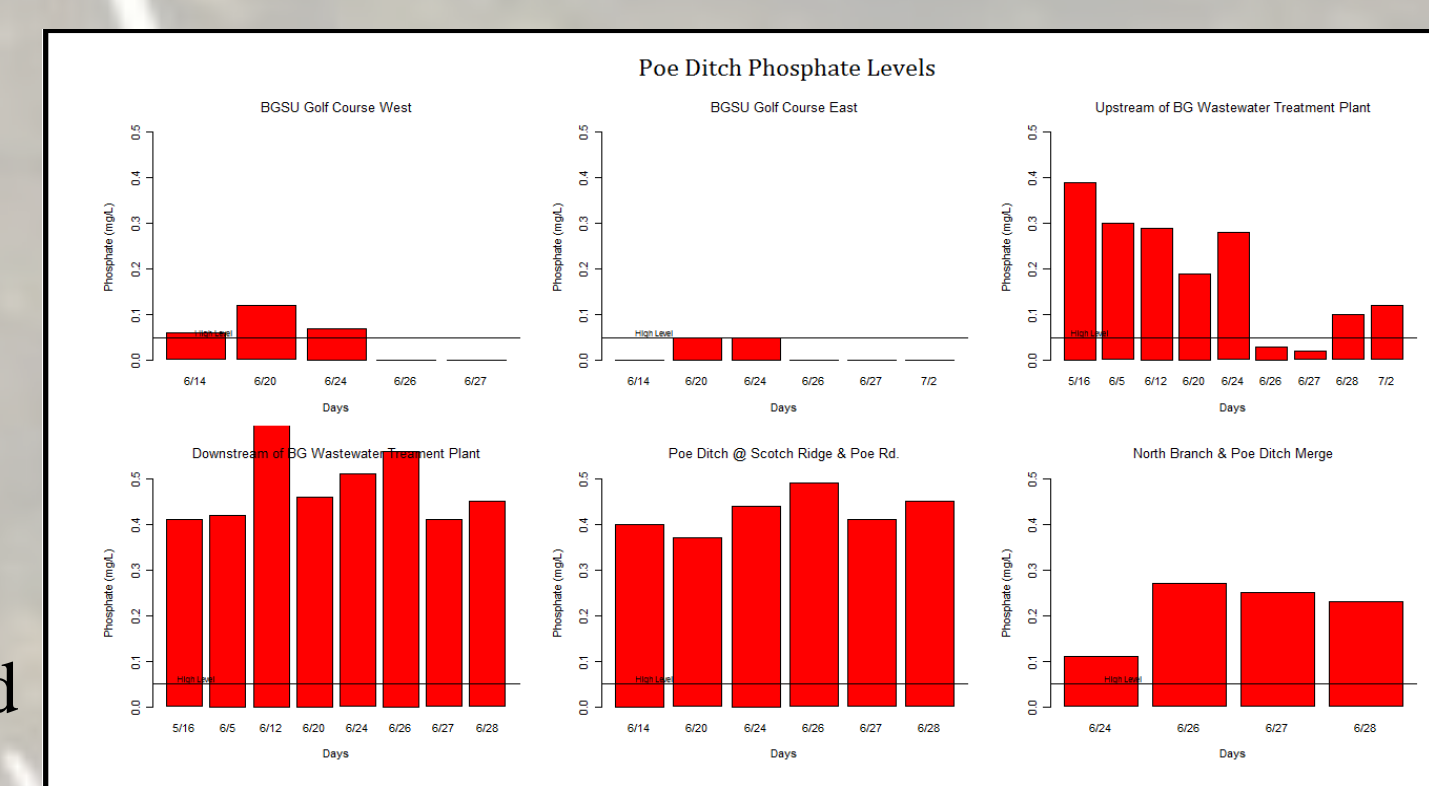
Figure 6: This figure shows the phosphate levels for Poe Ditch.

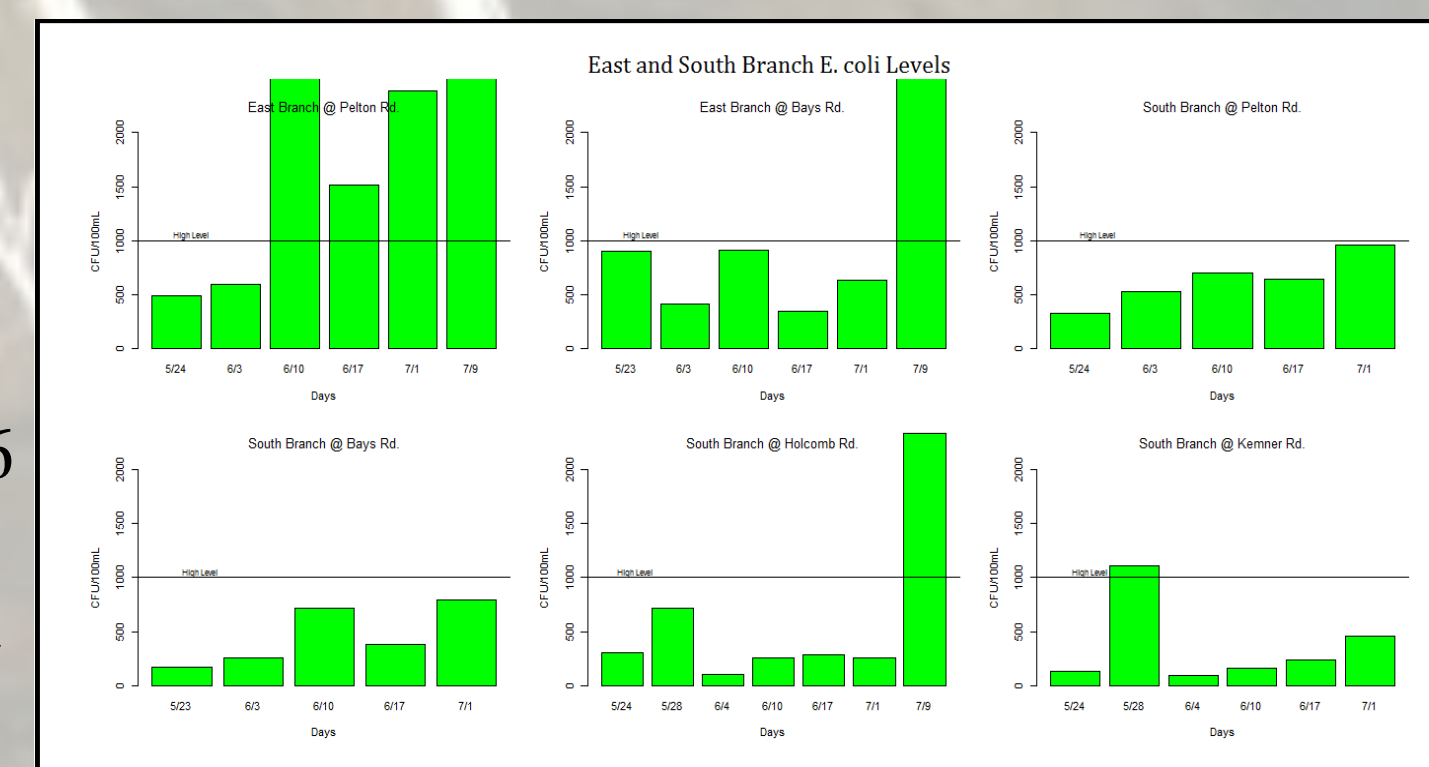
Figure 7: This figure shows the *E. coli* levels for the South and East Branch tributaries of the Portage River.

The highest *E. coli* contamination, at Pelton Rd. on the East Branch, is downstream from the Fostoria Wastewater Treatment Plant and may be residual from overflow events (Figure 7). Fostoria hopes to separate storm water from regular wastewater by 2026 to reduce contamination (The Toledo Blade, 2006).

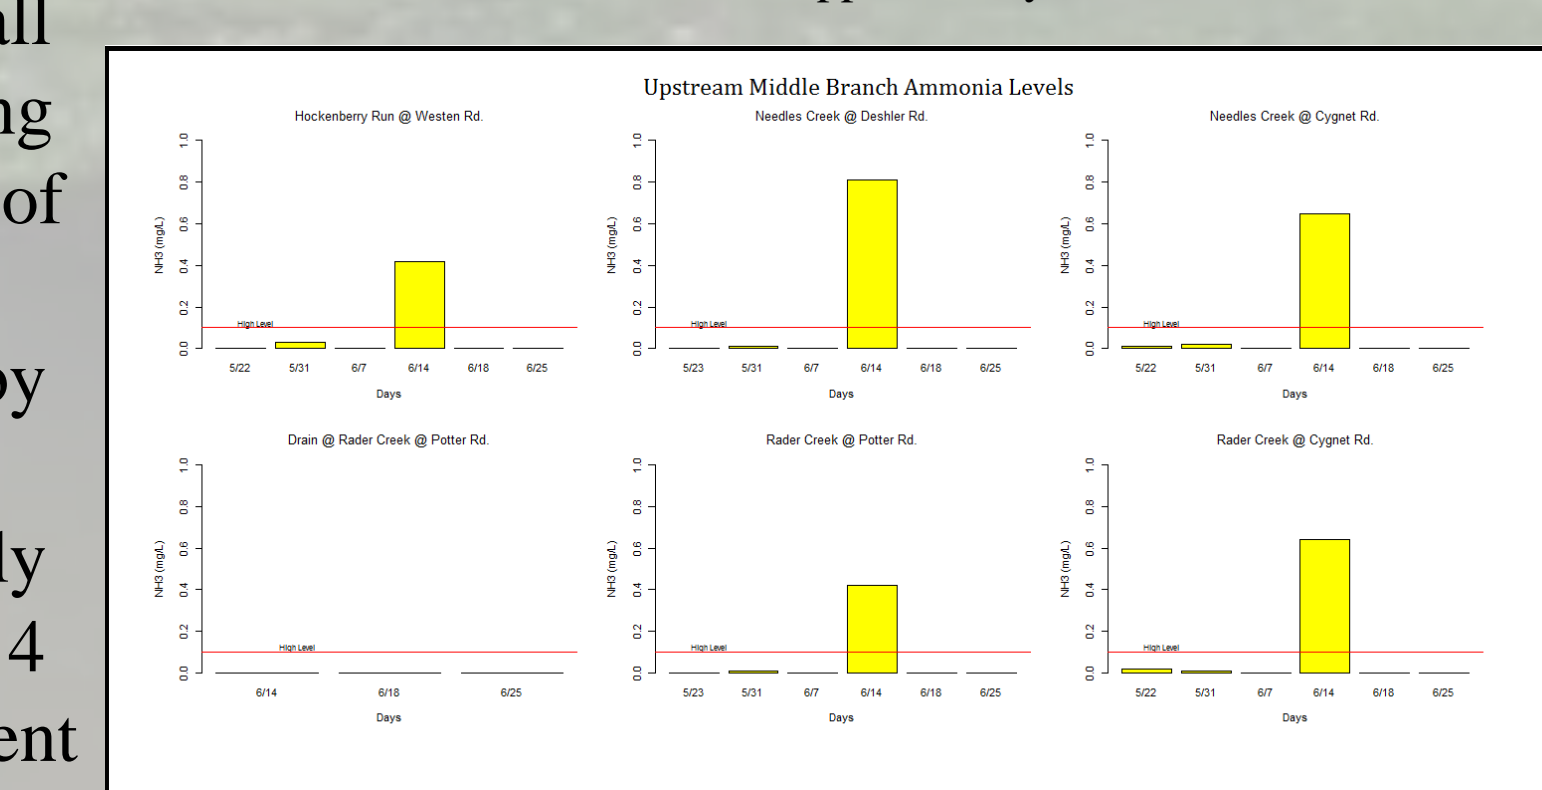
Figure 9: This figure shows the ammonia levels for the upstream tributaries that make up the Middle Branch.

The Middle Branch spikes after rainfall events symbolizing nonpoint sources of contamination of runoff from nearby fields. Ammonia levels are normally low except on 6/14 after a rainfall event of .81 in. the ammonia levels increase (Figure 9).

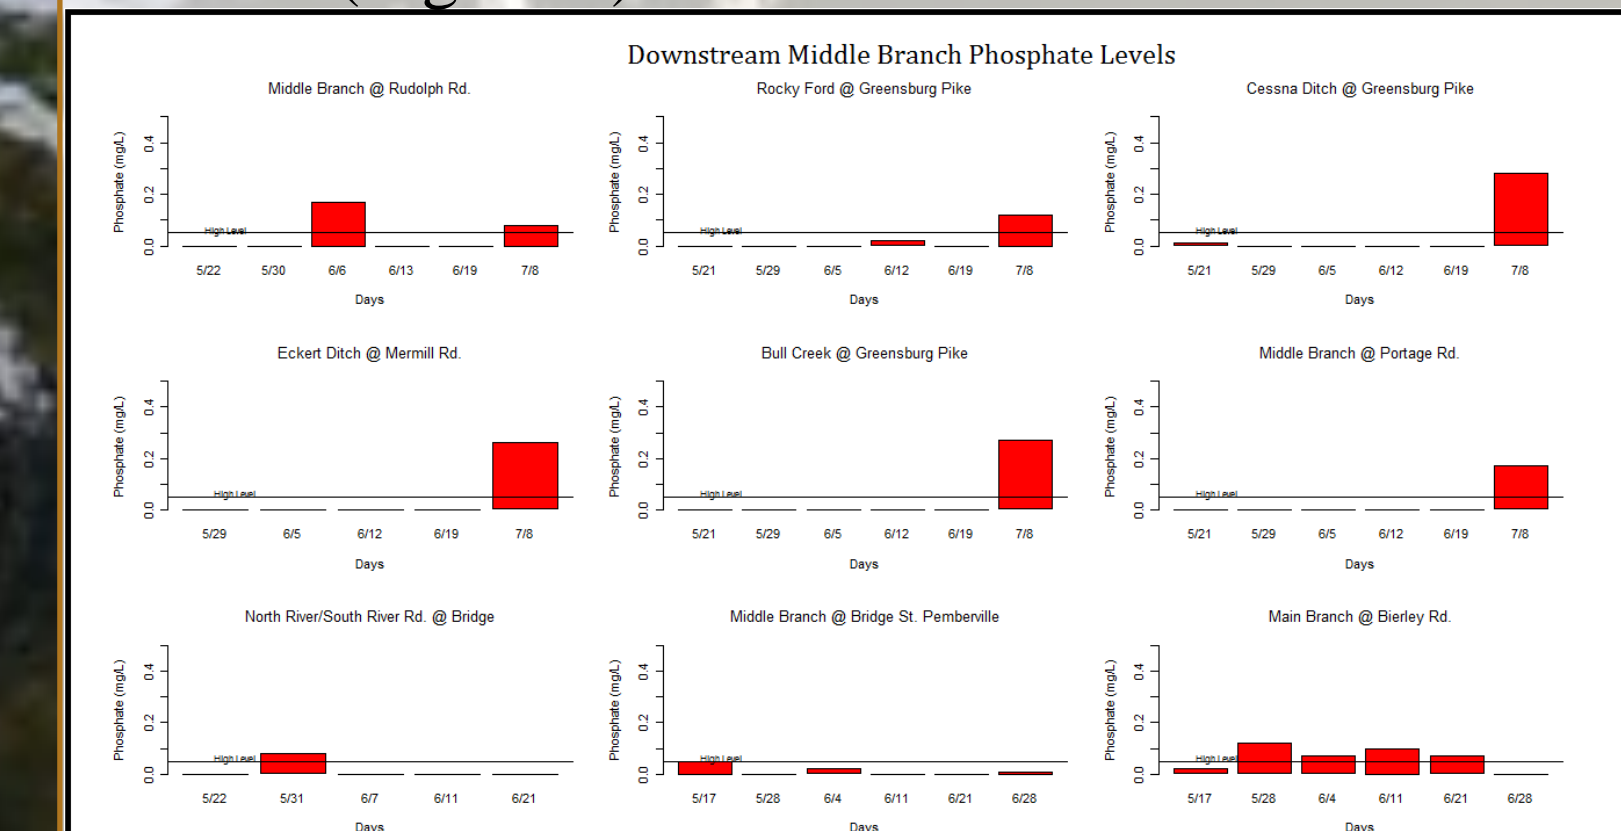
Figure 10: This figure shows the dissolved phosphate levels for the downstream tributaries that make up the Middle Branch.

A similar event with phosphate happened further downstream on 7/8 after a rainfall event of .87 in. (Figure 10).
